NBS TECHNICAL NOTE 807

Building Performance in the 1972 Managua Earthquake

Following the Managua, Nicaragua, earthquake of December 23, 1972, a team of engineers representing the U.S. Department of Commerce's National Bureau of Standards (NBS) and the National Academy of Engineering (NAE) performed field investigations in Managua, Nicaragua, from December 26, 1972, to January 4, 1973. The objectives were to assist the Nicaraguan government in surveying major buildings to determine whether each was suitable for emergency use, repairable, or appropriate for clearance. The team also viewed the patterns of successful performance and damage to identify needs for improvements in building practices for mitigation of earthquake hazards and opportunities for more detailed investigations which could provide information for future improvements in practices.

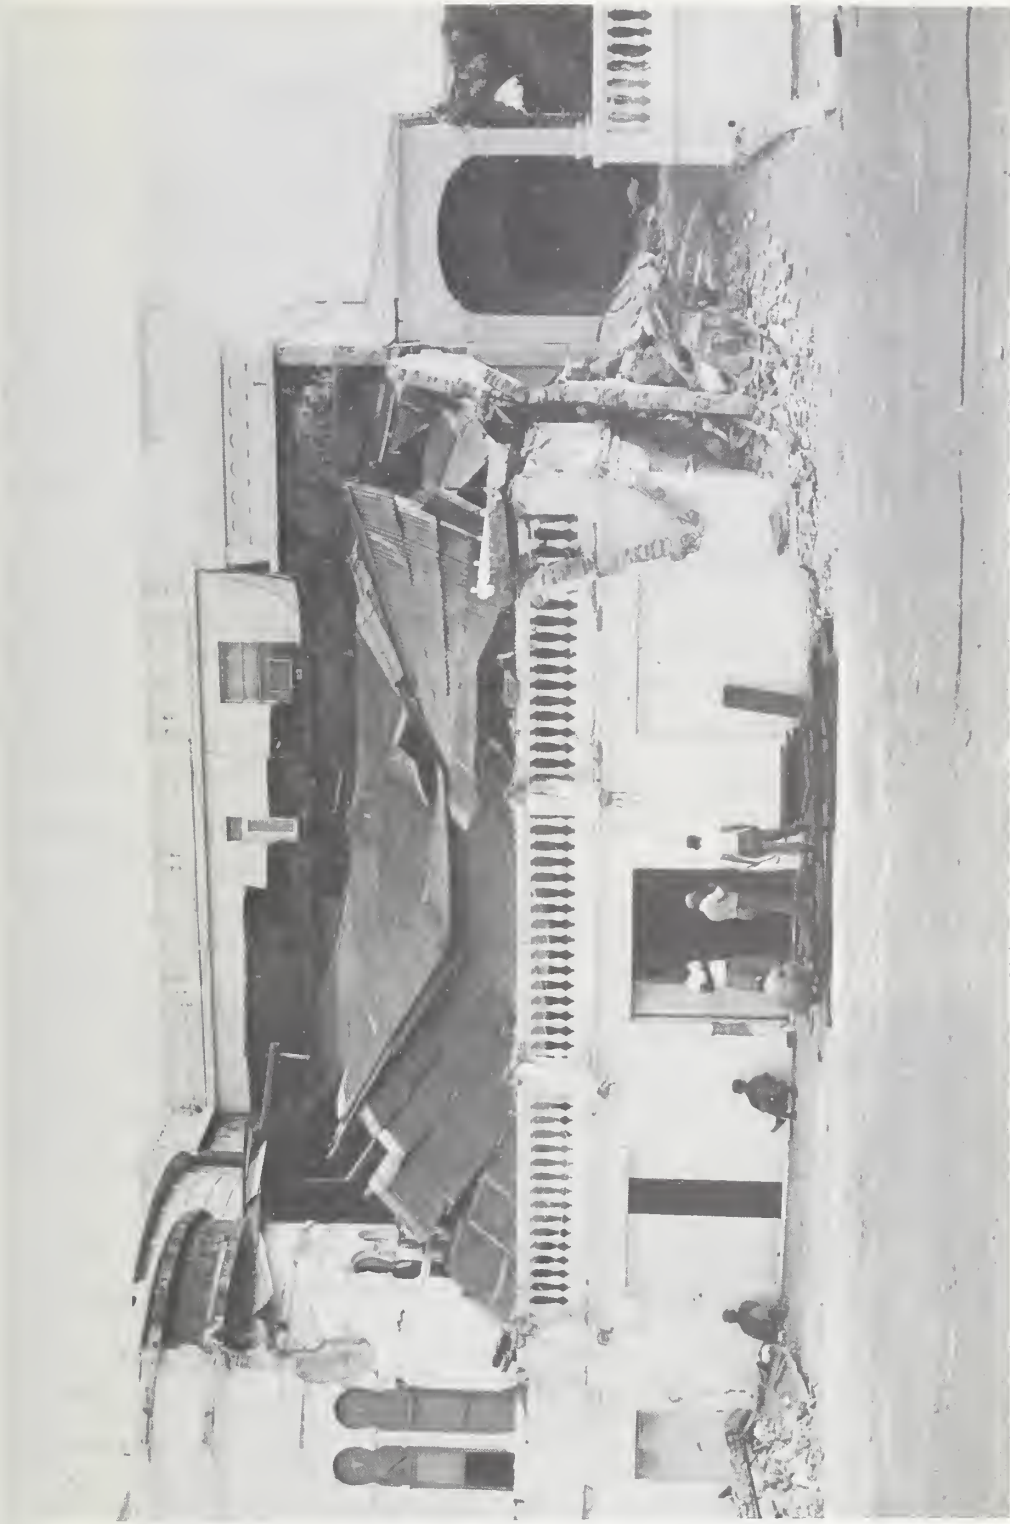
Figure 57-1 Collapse of roof over terrace, Casa Presidencial.

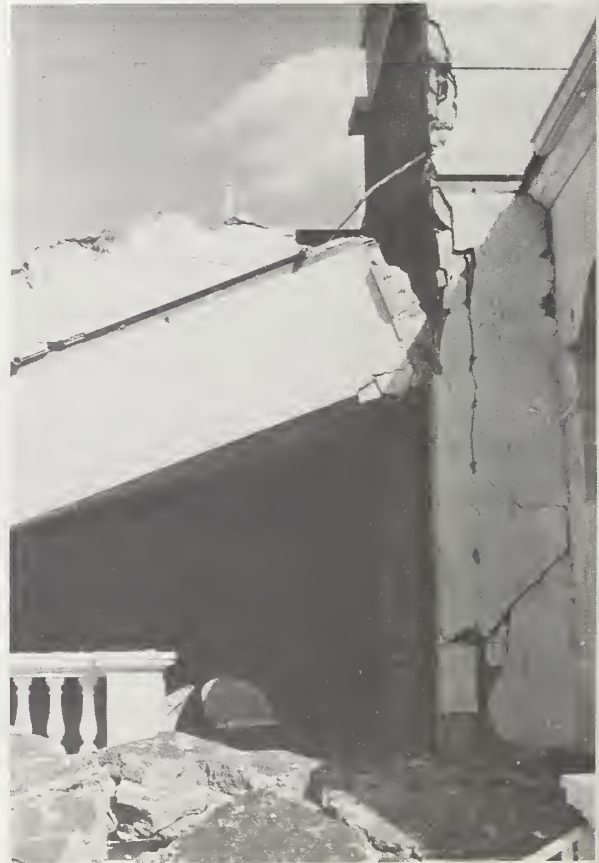
Figure 60-2 Detail of collapsed terrace roof, Casa Presidencial.

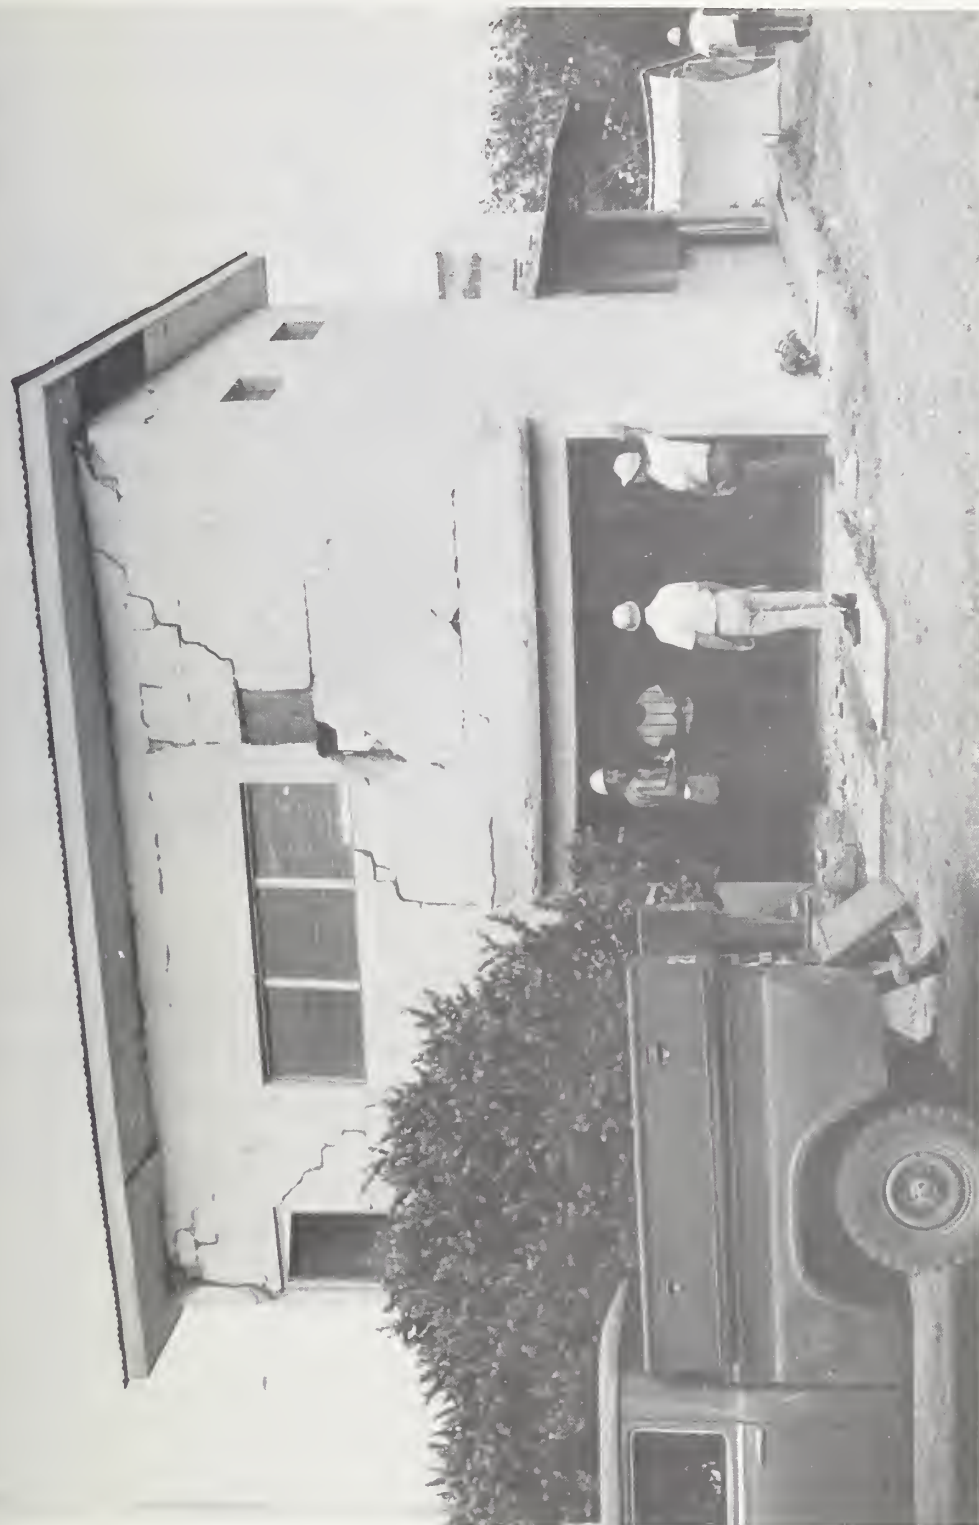
Figure 62-1 A very fragile building housing the country's radio transmission equipment, Radio-Difusora Nacional.

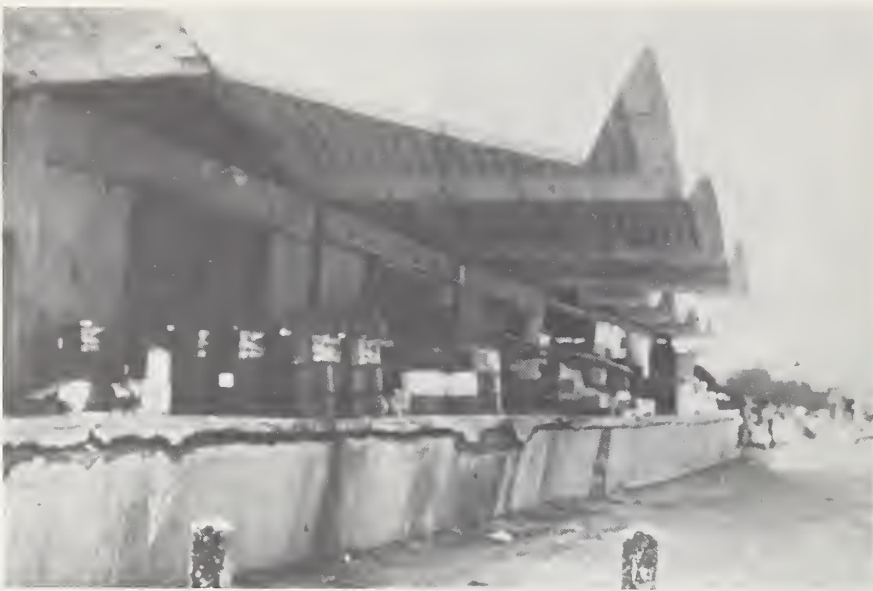
Many of the structural failures in Managua can be attributed to inadequacy of the structural systems for the lateral forces imposed by the earthquake. Heavy barrel shell roofs such as that of the Aduana (Customs House), figure 68-3, sheared their columns, figure 68-4, and collapsed or came to rest upon the contents of the building. Many multistory reinforced concrete buildings collapsed such as the Guerrero Pineda five story building, figure 74-2. Some modern one story buildings such as the INCET (National Granary) administration building, figure 16-1, appear to have been constructed with unnecessarily heavy roofs and framing systems inadequate for the resulting lateral forces. There was evidence in the Instituto Pedagogico, figure 46-3, that flat slabs showed some distress in functioning as the horizontal framing member between columns.

Figure 68-3 General view of damaged barrel shed,
Aduana General de Managua.

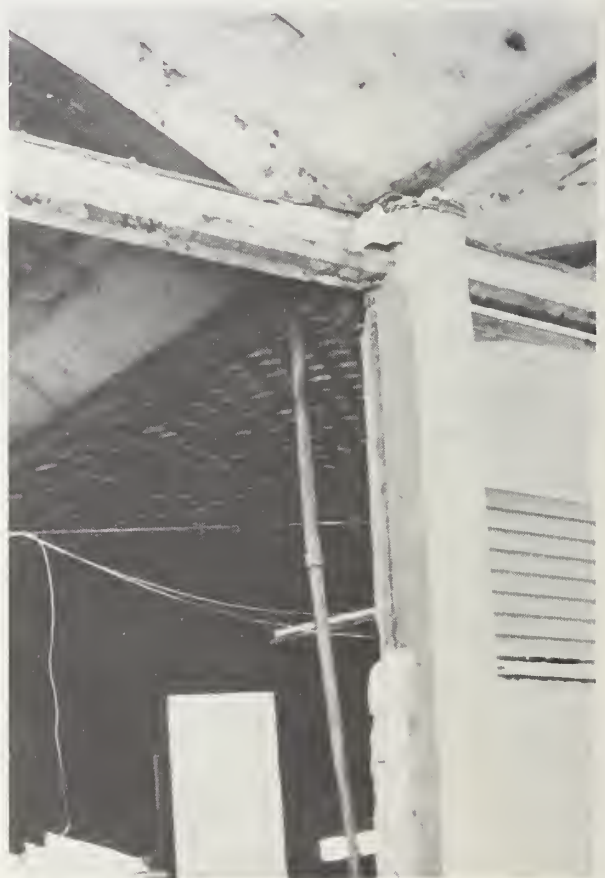
Figure 68-4 Close up of sheared
exterior columns,
Aduana General de
Managua.

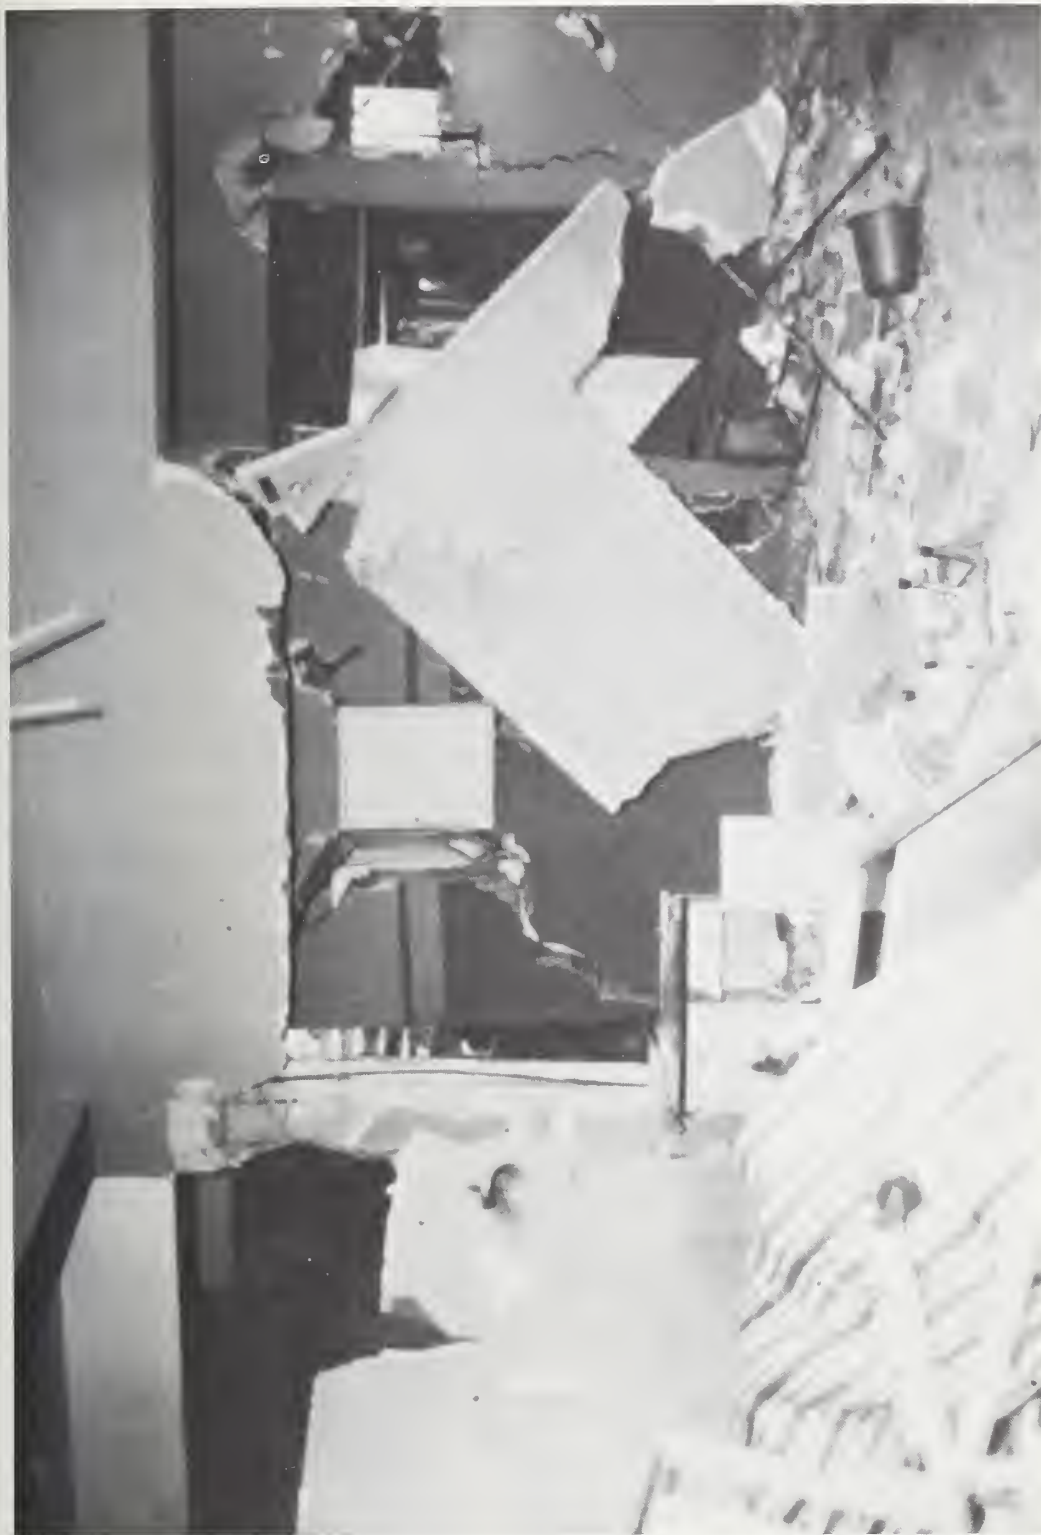
Figure 70-5 Structural and nonstructural damage in wards, Hospital del INSS.

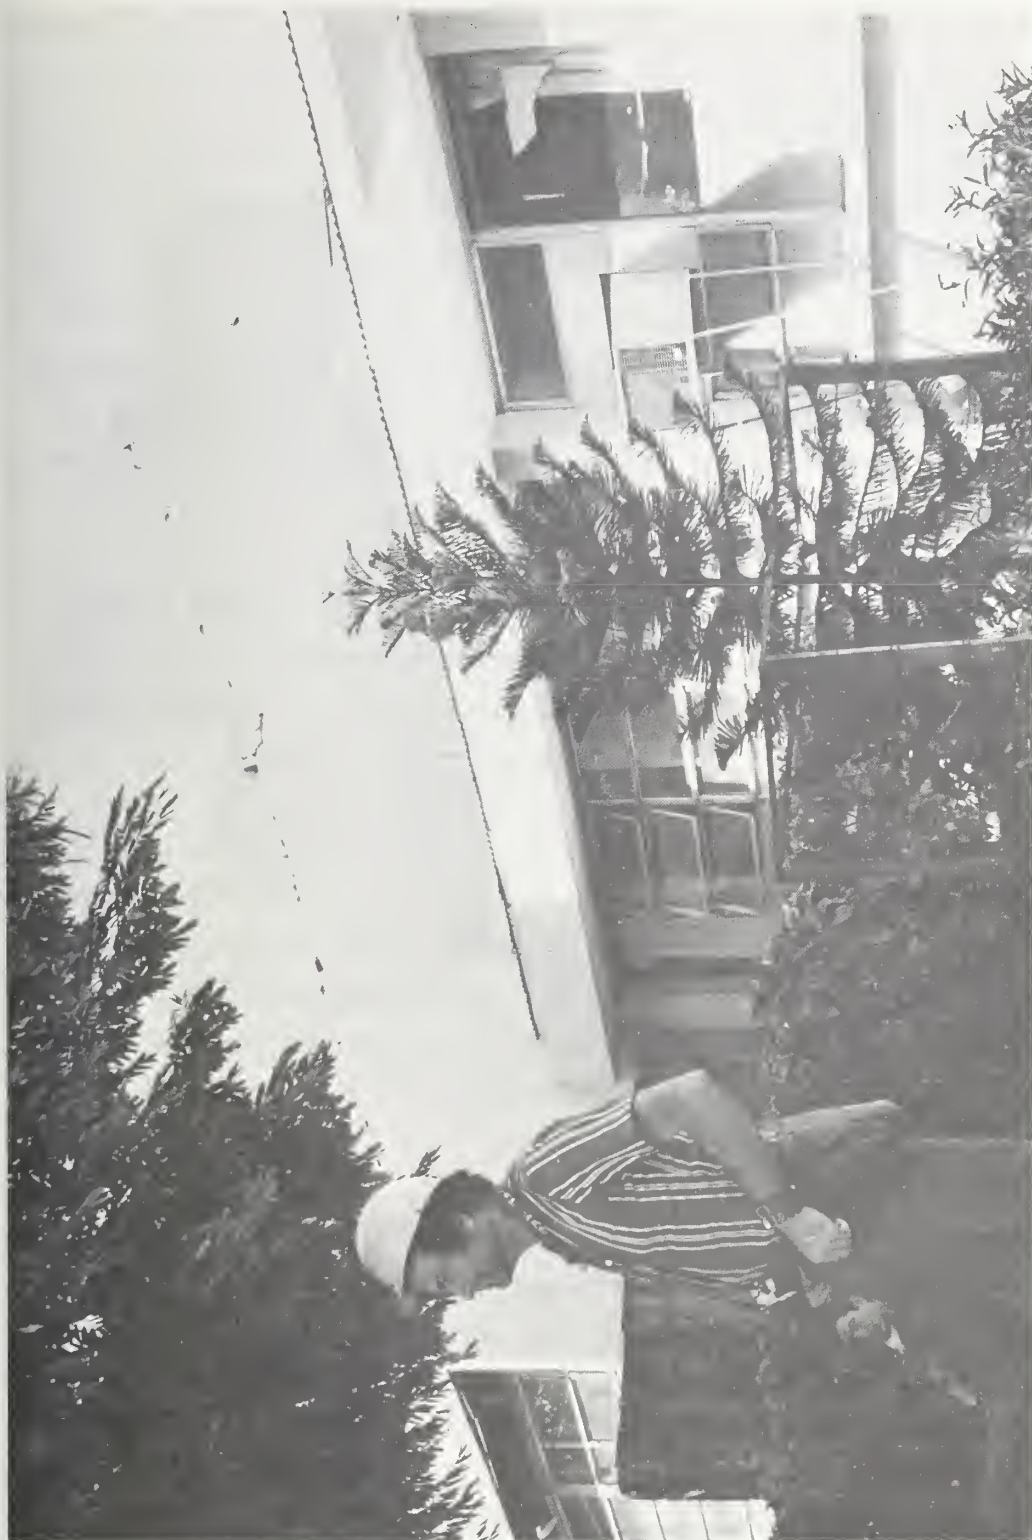
Figure 71-1 Cracked parapet walls, Policlínica Central del INSS.

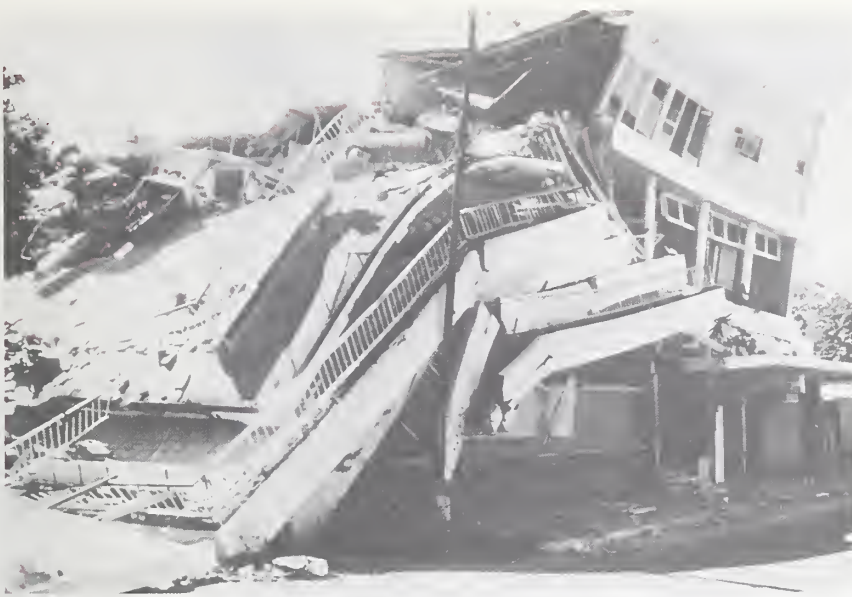
Figure 74-1 Four of five stories collapsed, Edificio Guerrero Pineda.

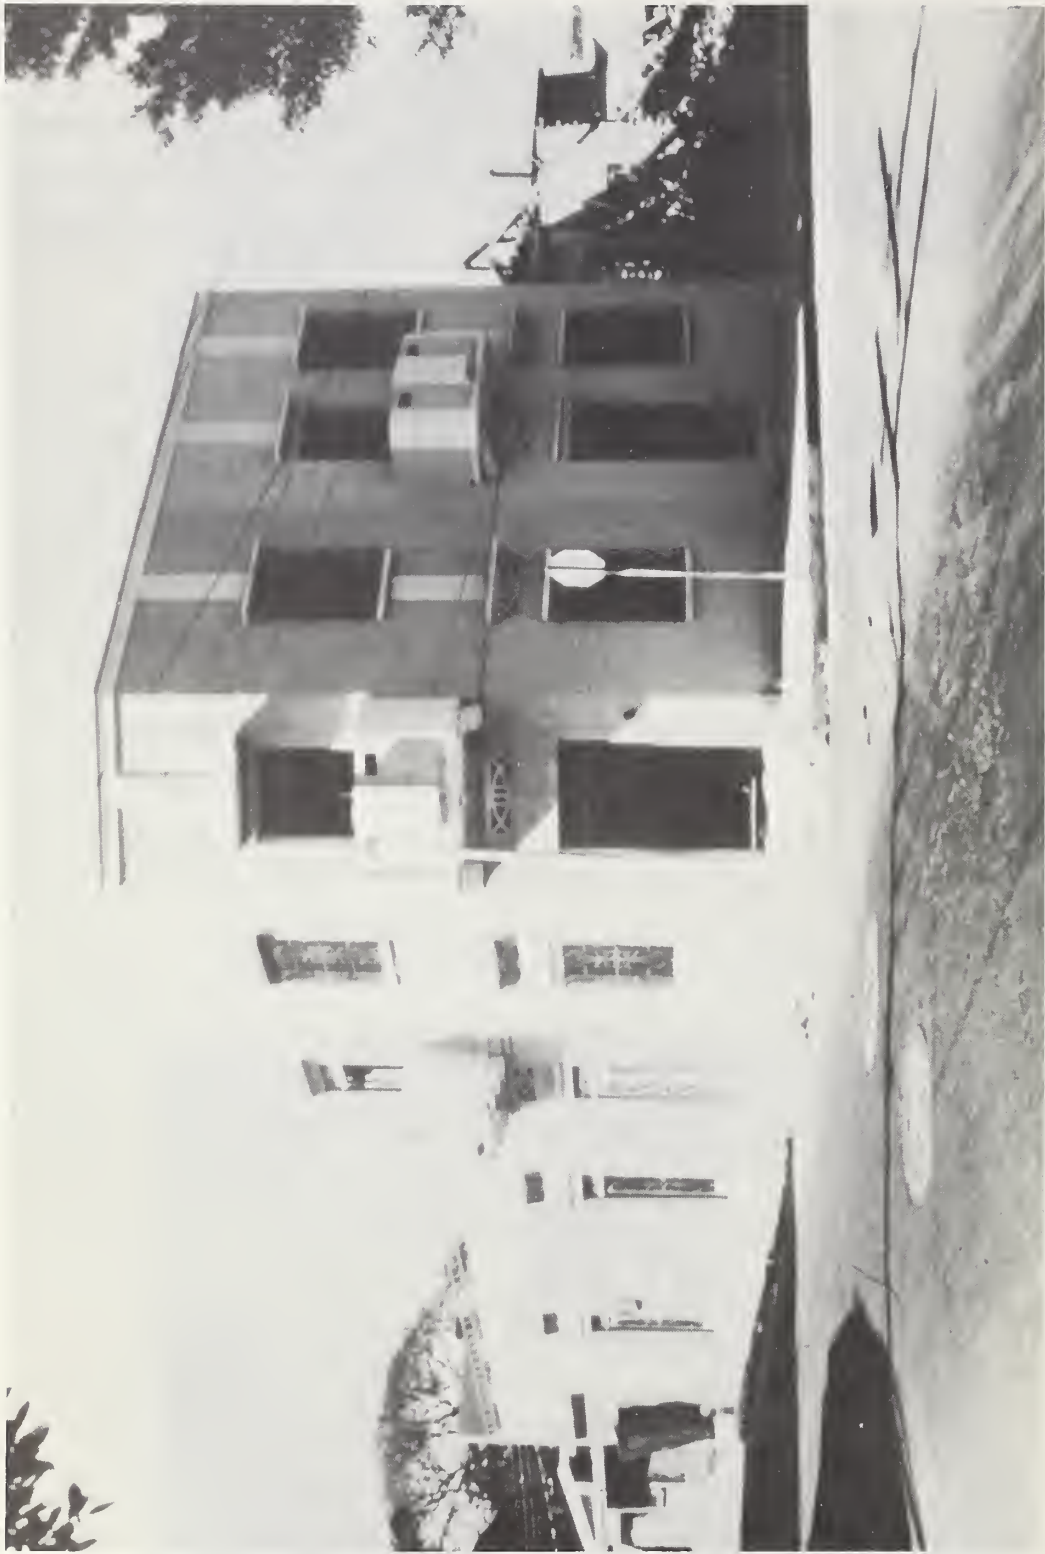
Figure 74-3 Building across from Guerrero Pineda shows little damage.

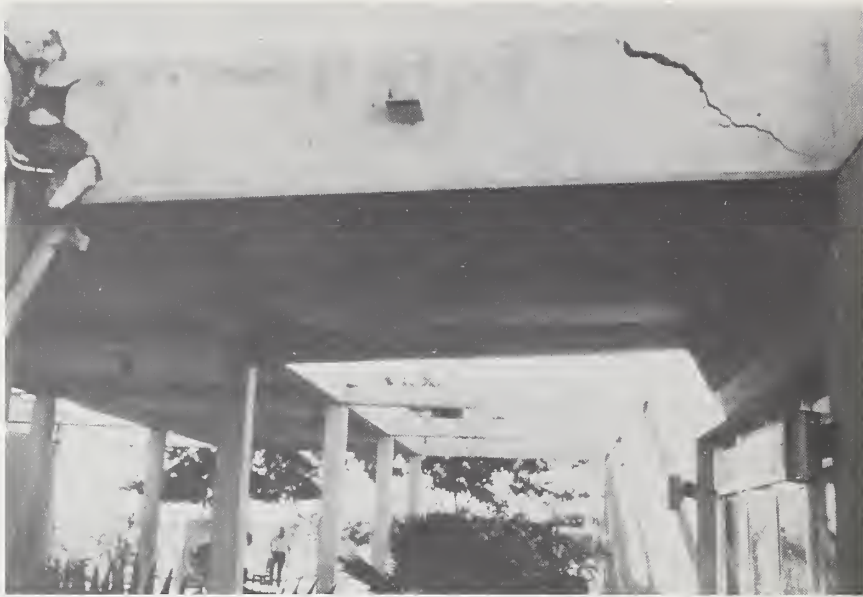
Figure 75-1 Damages to canopy between buildings,
Instituto Geografico Nacional
